How to fix GEN 2 Wheelchair squeaky parts

This guide will show how to fix squeaky parts on the wheelchair.

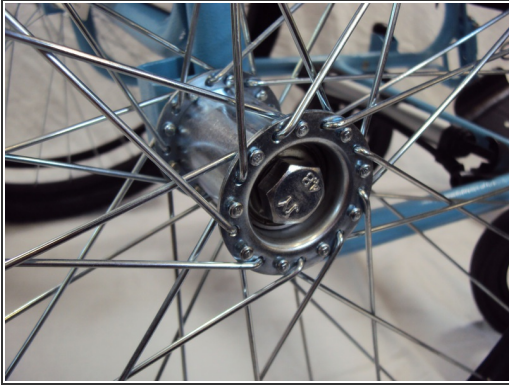
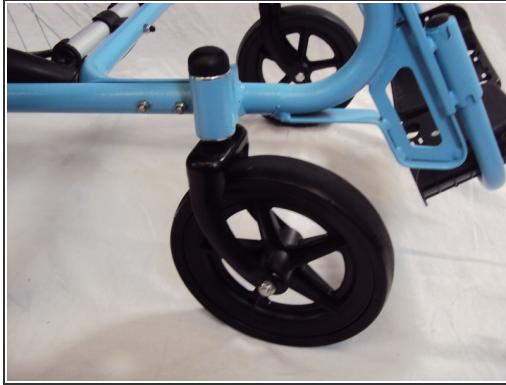
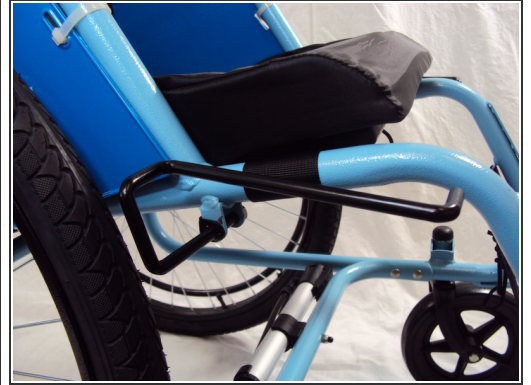
Step 1 — How to fix GEN 2 Wheelchair squeaky parts

- Locate the source of the squeaking.
- ⓘ Typically, this will be one of the rear wheels, castor wheels, or brakes.
- Clean and remove any dirt or rust from the source of the squeaking.
- ⓘ You may need to partially disassemble the squeaky part in order to thoroughly clean it.

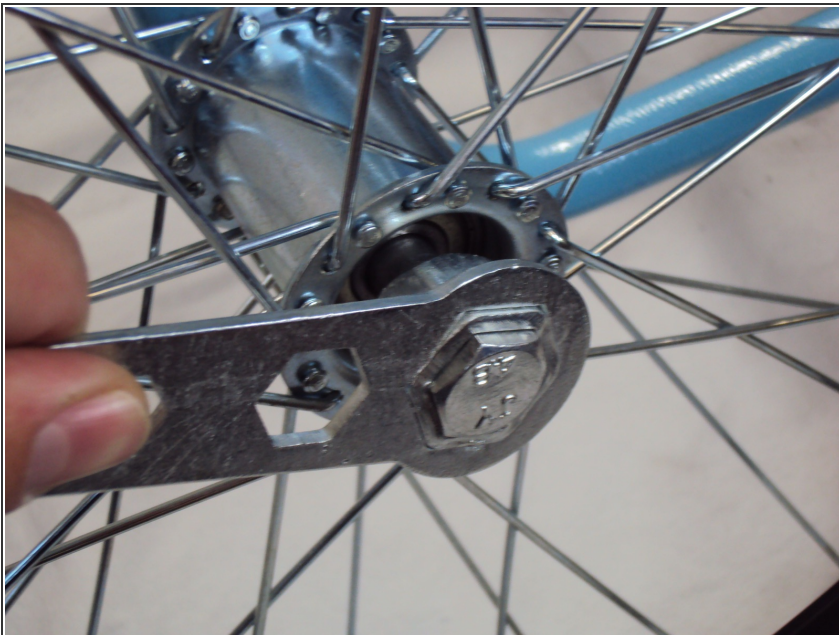
Step 2

- Check for improper assembly.
- ⓘ Refer to the teardown to check that the wheelchair is properly assembled.
- Check for proper lubrication. If not lubricated, lubricate thoroughly with bike grease.

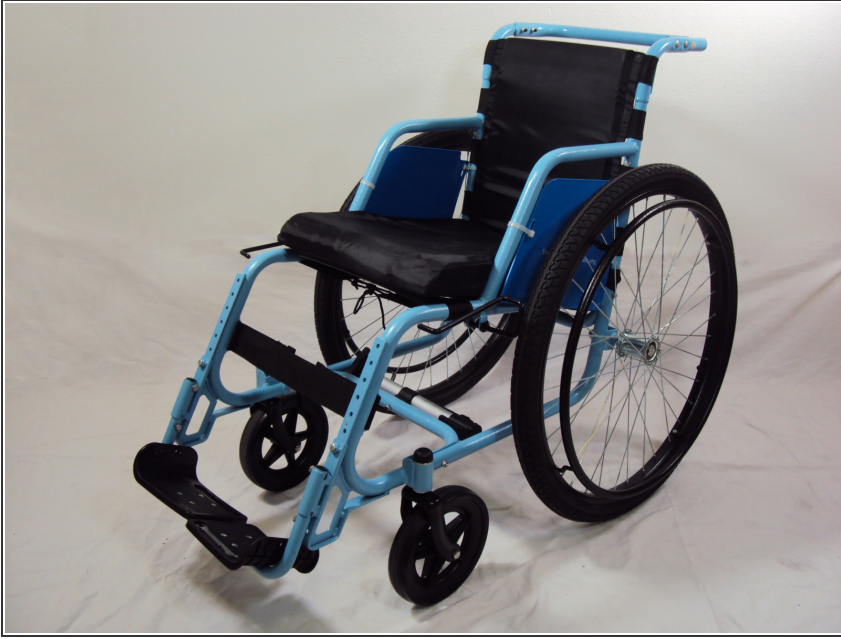
Step 3

- Roll the wheelchair around to check if the squeaking has stopped.
- ⓘ If the squeaking still continues, recheck the chair until the problem is fixed.

Squeaking can be caused by overly tightened connections. If problem still occurs after going through steps, try to slightly loosen bolts (half a turn of the wrench) near the source of squeaking.
